ST. JOE STATE PARK DAM  
ST. FRANCOIS COUNTY, MISSOURI  
MO 30277

# PHASE 1 INSPECTION REPORT NATIONAL DAM SAFETY PROGRAM

FEBRUARY 1980

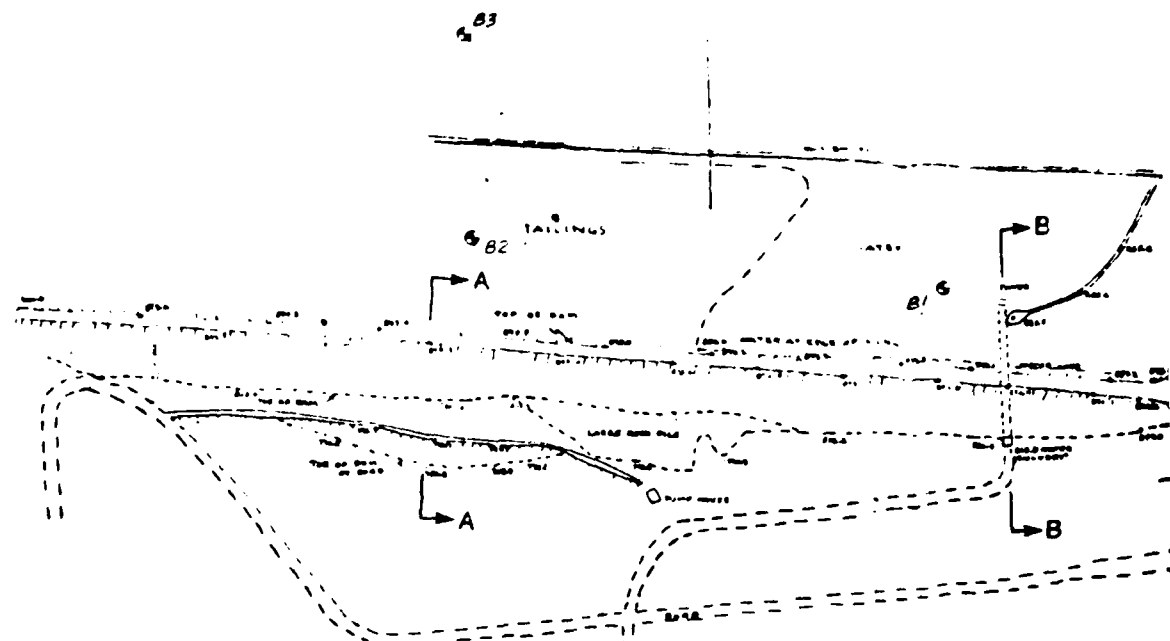
PLAN VIEW OF ST. JOE  
TAILING DAM AND BORING LOCATIONS  
FIGURE 1
